# Belvidere Theatre

129 Nevada Street  
Central City, Colorado 80427

Historic Structure Assessment and  
Preservation Plan  
SHF Grant No. 2016-HA-005  
Deliverable #5 Final HSA  
July 2016

**HISTORIC STRUCTURE ASSESSMENT  
AND  
PRESERVATION PLAN**

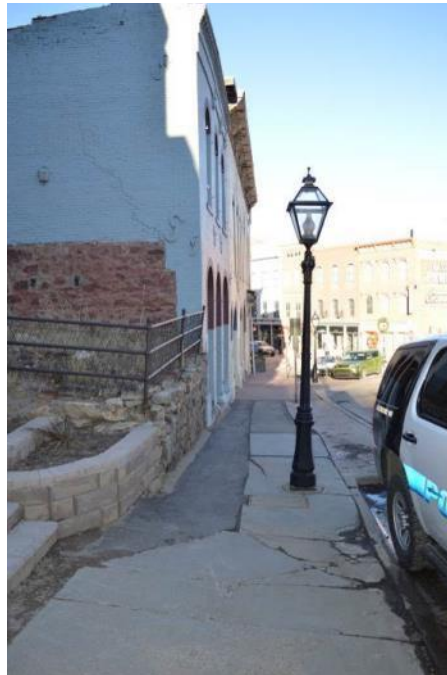
*Figure 14: Overall view of concrete and asphalt paved sections of sidewalk to the southeast of the building.*

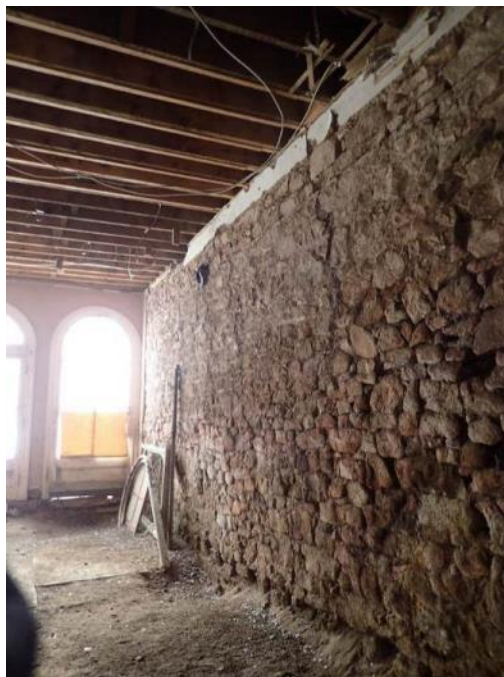
*Figure 29: Southern lower level masonry wall in the Shoo Fly portion of the Building. Note that the foundations were not exposed.*

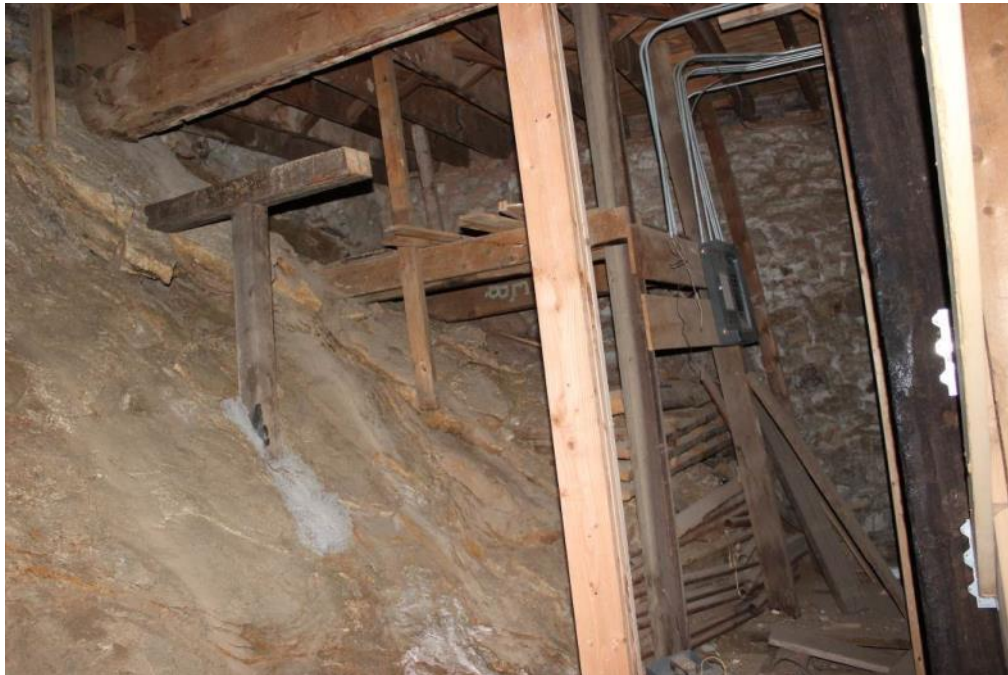
*Figure 33: Interior stage floor framing bear on the sloping stone wall with a variety of bearing conditions*

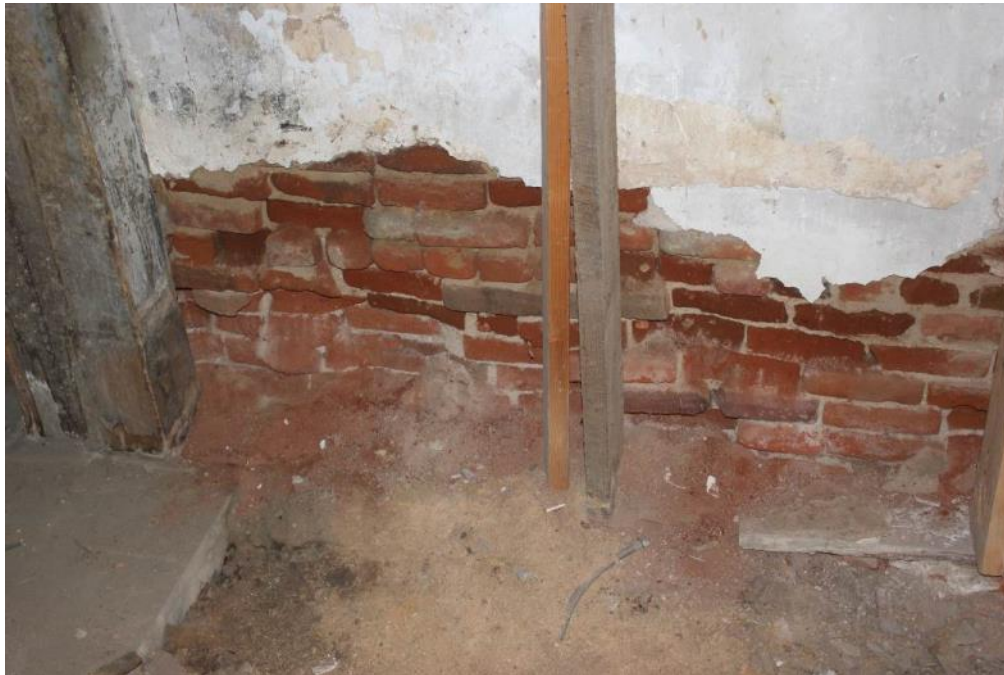
*Figure 34: Deterioration at the bottom of the brick wall between Room 02 and Room 03 due to rising damp*

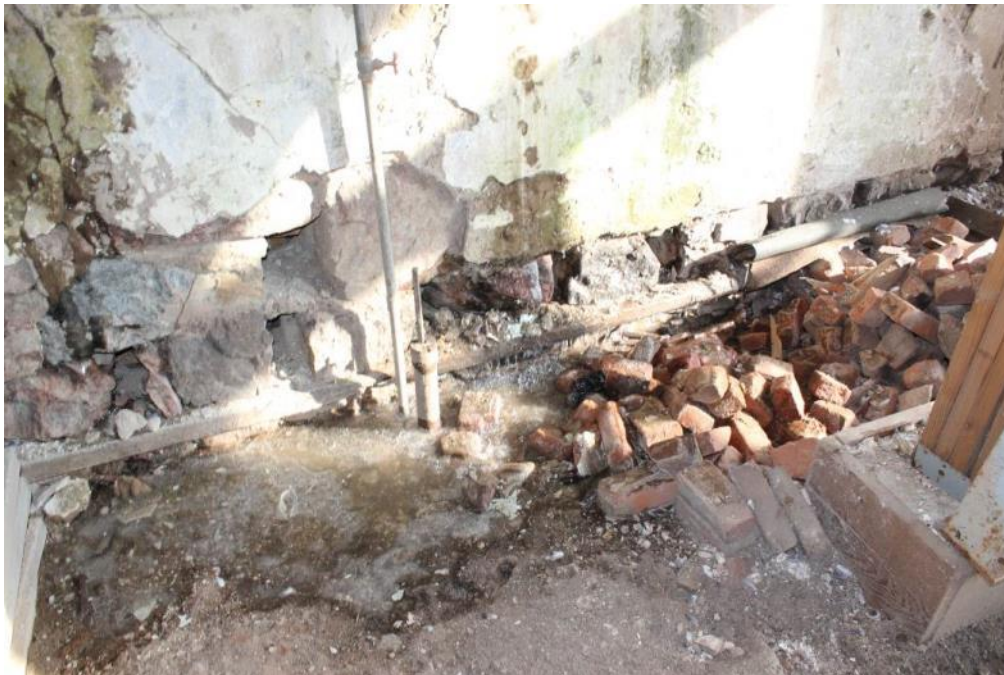
*Figure 35: Water entering through a hole in the roof of the Shoo Fly as seen in Room 01 of the lower level*

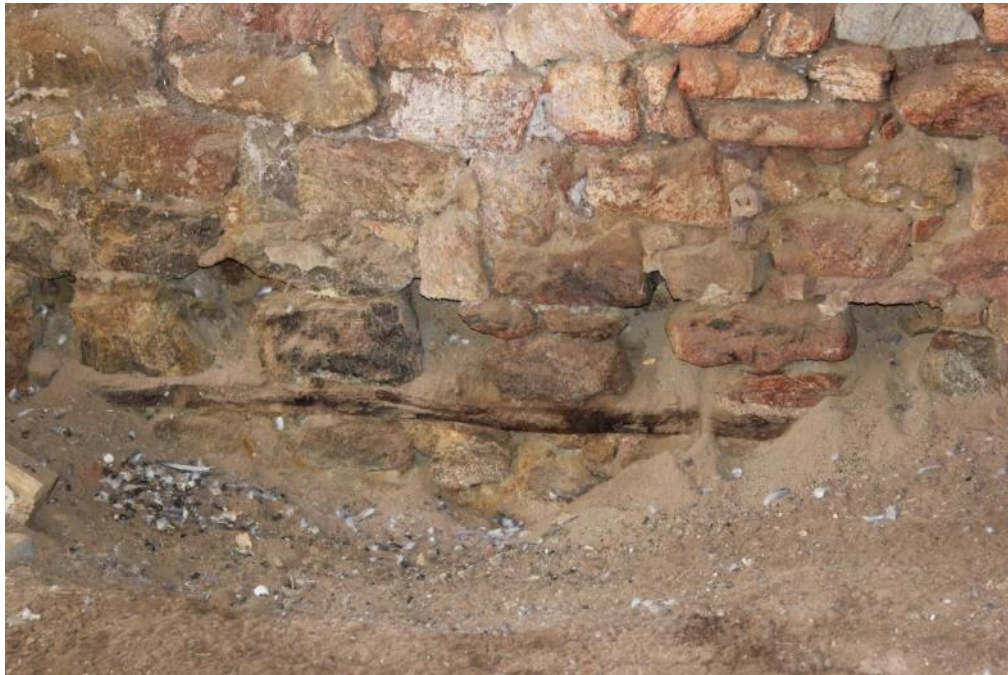
*Figure 37: Former joist pockets for the lower level of the Shoo Fly*

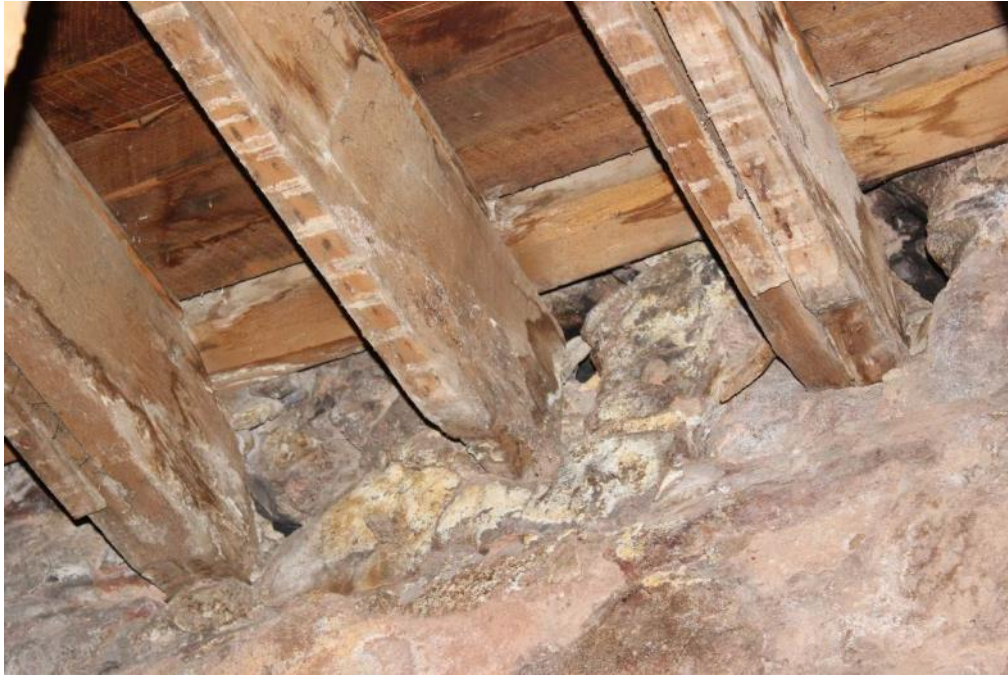
*Figure 47: The ends of most of the upper level joists throughout the building have decayed and have limited bearing remaining*

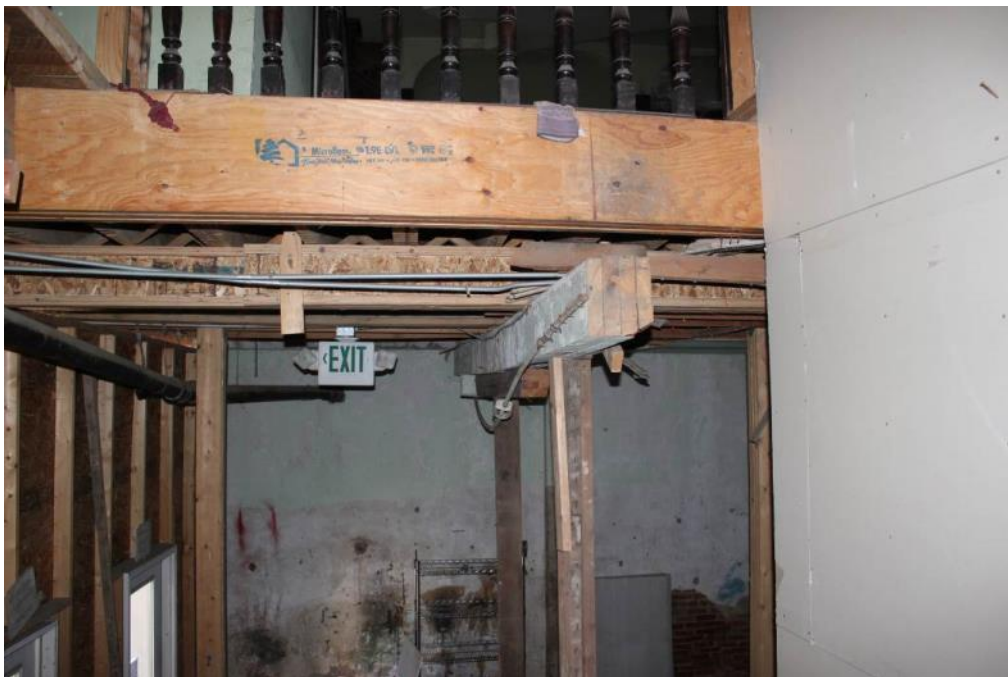
*Figure 48: The end of the trussed beam has been removed and the tie rod has been shortened and attached to the side of the remaining beam*

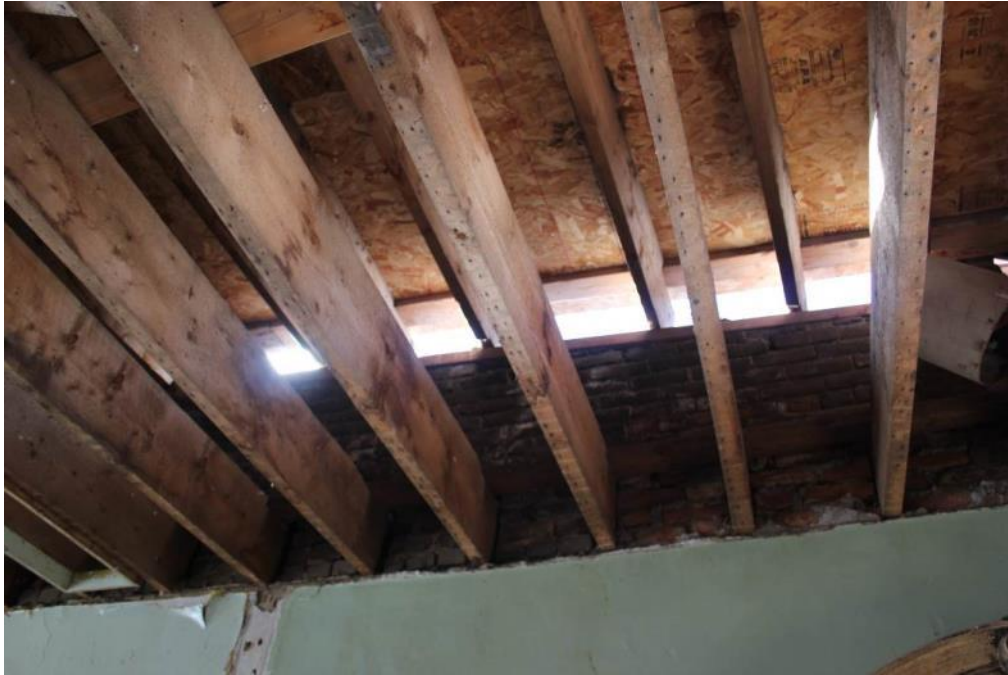
*Figure 49: The ceiling joists and rafters of the Shoo Fly. Note that daylight is visible from the interior of the building*

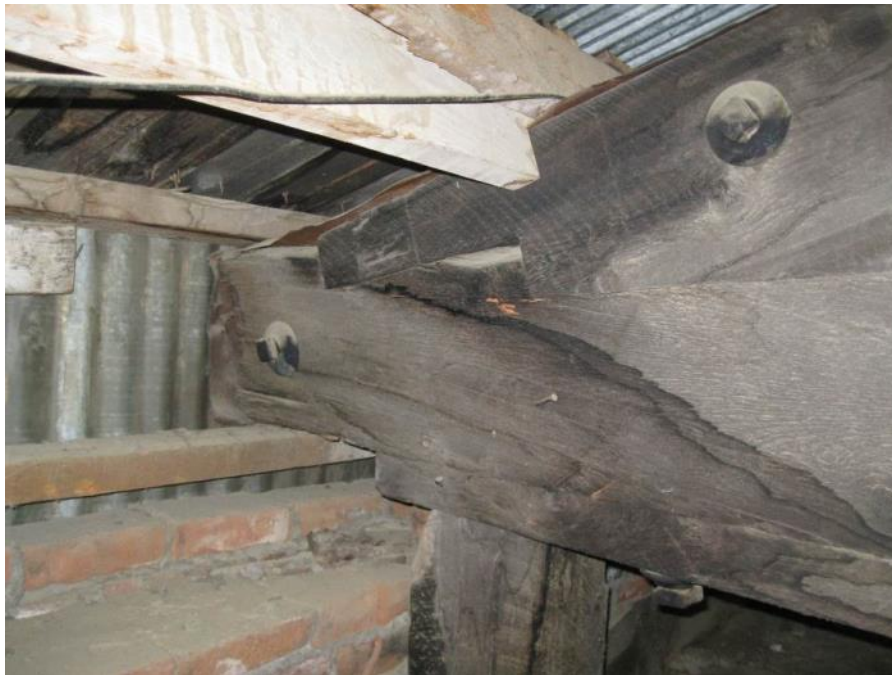
*Figure 56: The missing brick at the bearing point of the third timber roof truss from the east above the Theatre*

- Rebuild the southern brick bearing for the third truss from the east in the Theatre. (Serious)
- Confirm the configuration and condition of the Stage roof. (Serious)

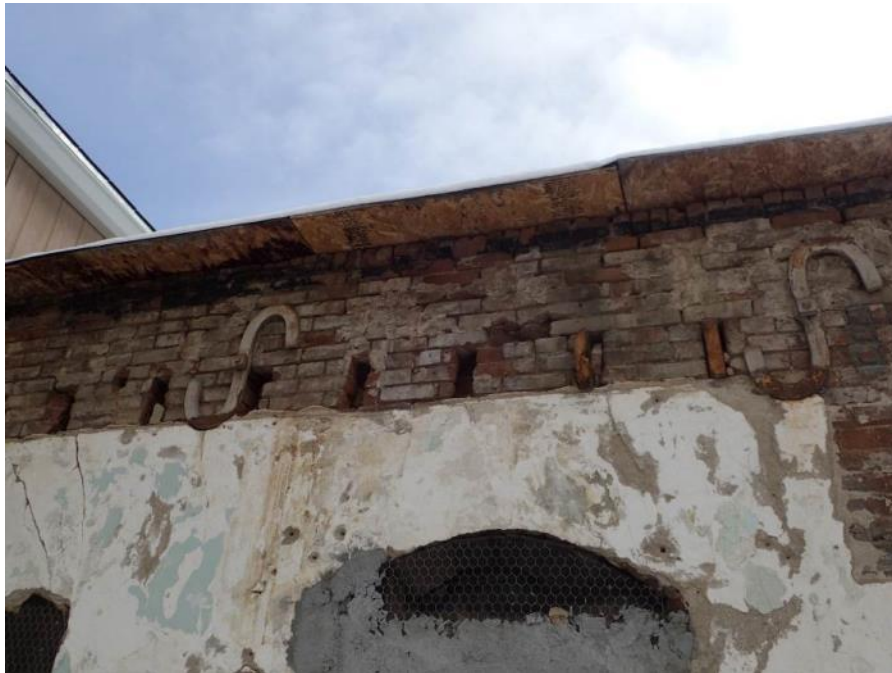
*Figure 63: Exterior ties and S-shaped anchors along the west wall of the Shoo Fly*

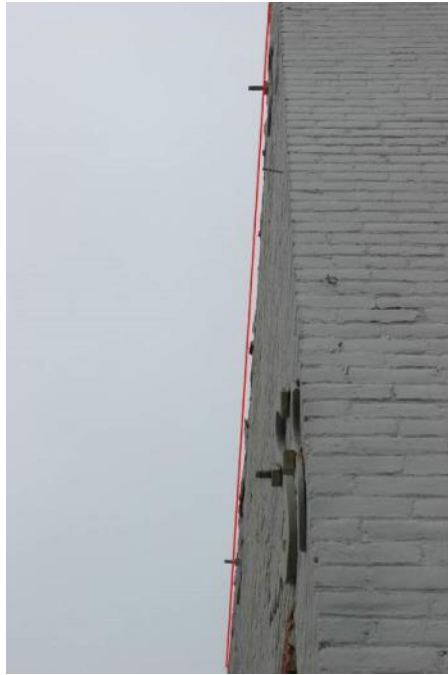
*Figure 66: The south wall of the Shoo Fly is leaning north due to the deteriorating wood plate embedded at the base of the wall on the interior of the structure. See the red reference line on the image.*

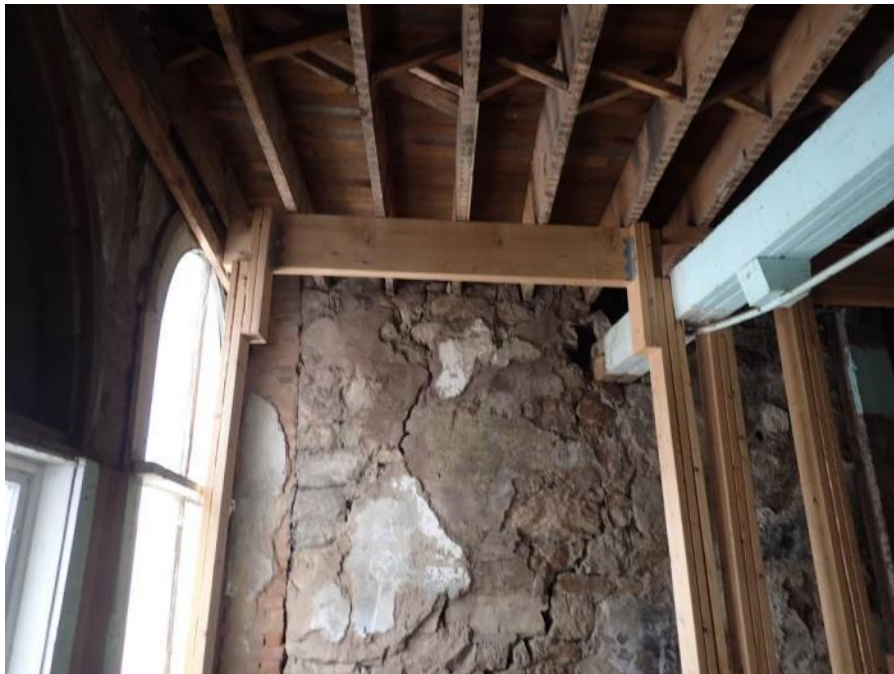
*Figure 67: Flexural cracks in the stone masonry wall due to the wall leaning to the north*

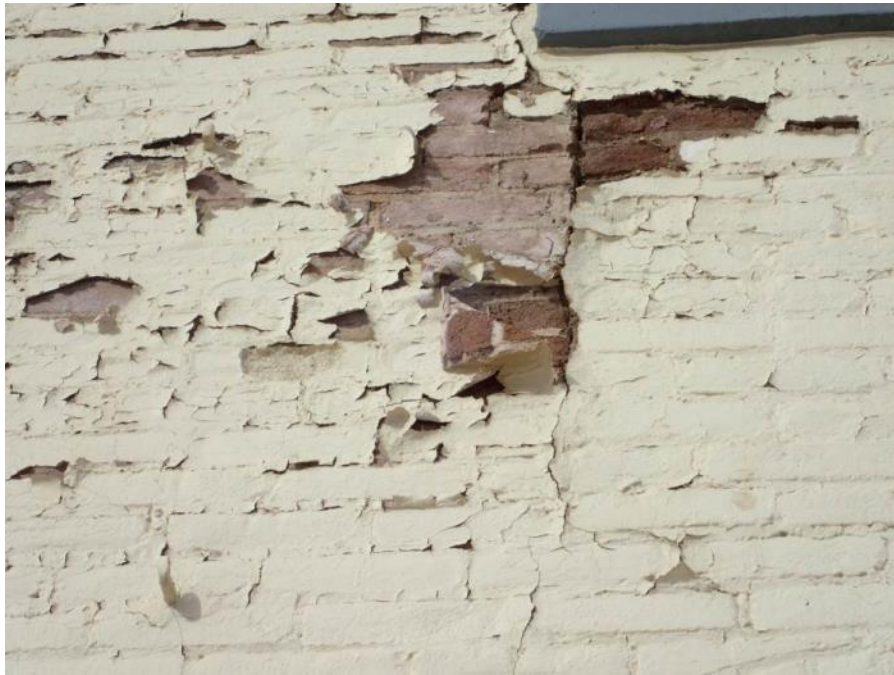
*Figure 68: The coating on the bricks, shown failing here, traps moisture against the brick masonry walls. This excess moisture adds to the effects and erosion due to freeze-thaw action*

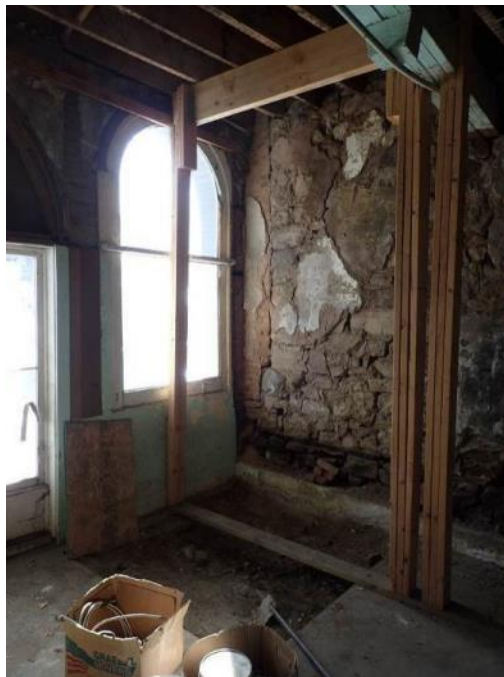
*Figure 69: Cracks in the masonry wall between Room 01 and Room 02. At the intersection of the perpendicular walls the movement is also displayed by the separation of the walls from one another*

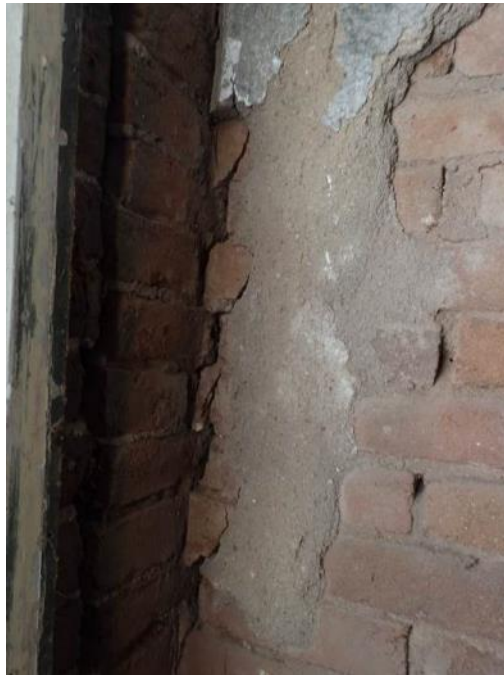
*Figure 70: At the intersection of the walls at the corner as seen in Figure 69, bricks tying the walls together have sheared off with the movement*

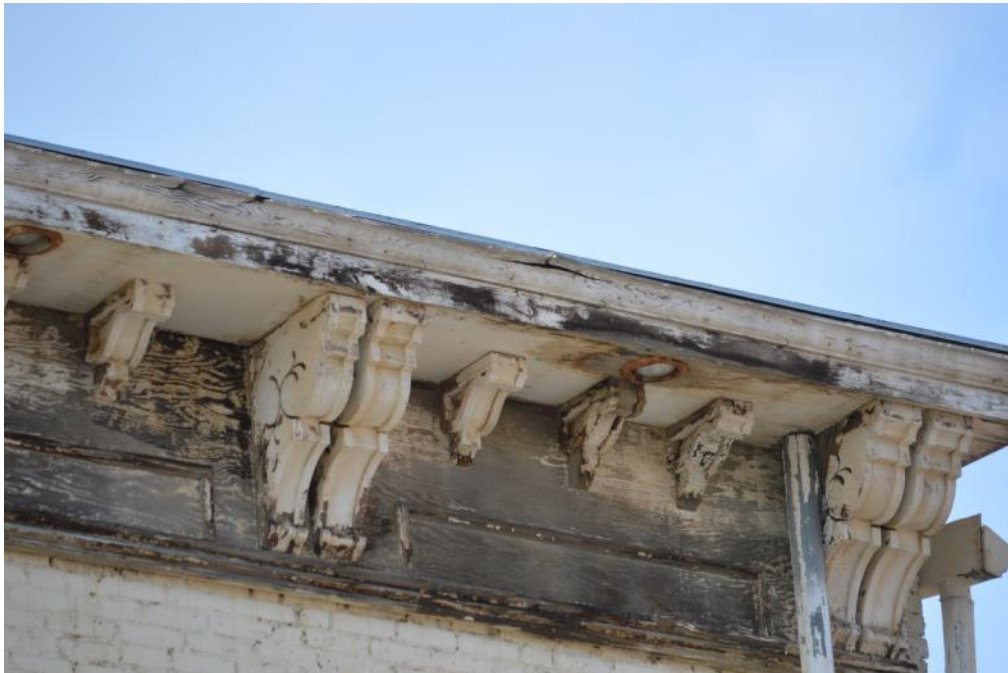
*Figure 73: Detail view of cornice condition along the east elevation of the theatre. Note extensive paint failure and wood deterioration typical along the cornice.*

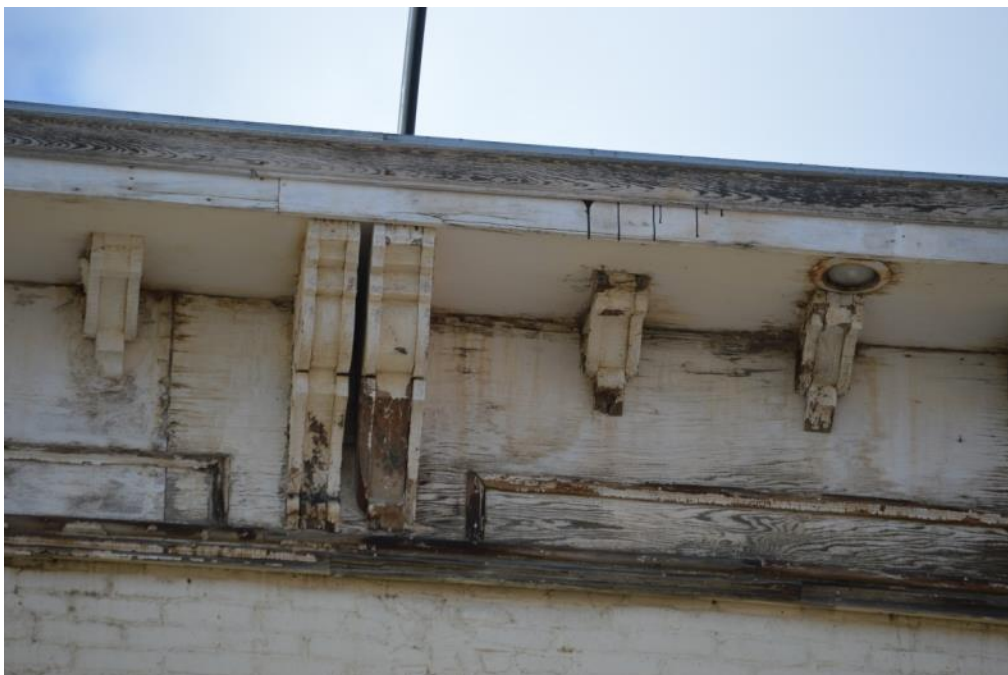
*Figure 74: Detail view of cornice along the east elevation of the theatre. Note paint and wood deterioration. Also note the tar drips between trim pieces at the top of the cornice. This joint is also where water leakage is occurring.*

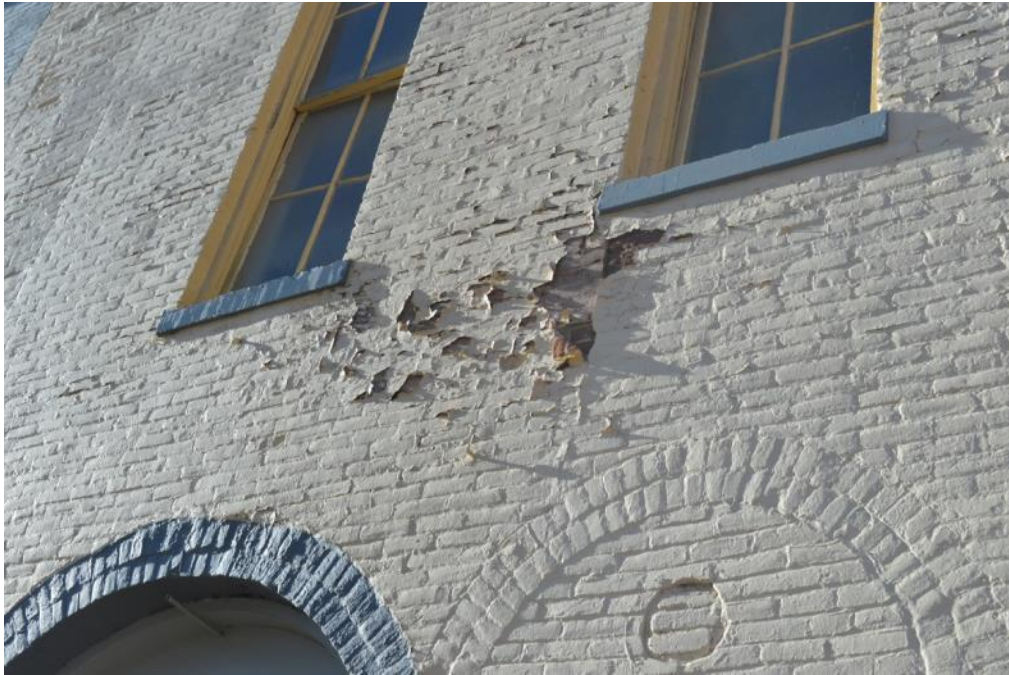
*Figure 80: Paint deterioration on the east elevation of the theatre section of the building.*

- Remove the paint coating from the exterior of the building. Once coating has been removed from the exterior of the building, rehabilitate brick masonry. If painting the building is appropriate and desired, a breathable coating appropriate for painting masonry should be used. (Critical)
- Replace missing and severely damaged brick at the section of the building to the south of the fly space. Repoint sections of brick as required. (Critical)
- Reconstruct the kitchen section of the building. The kitchen should be reconstructed using documentation of the original kitchen to design the reconstruction work. (Serious)

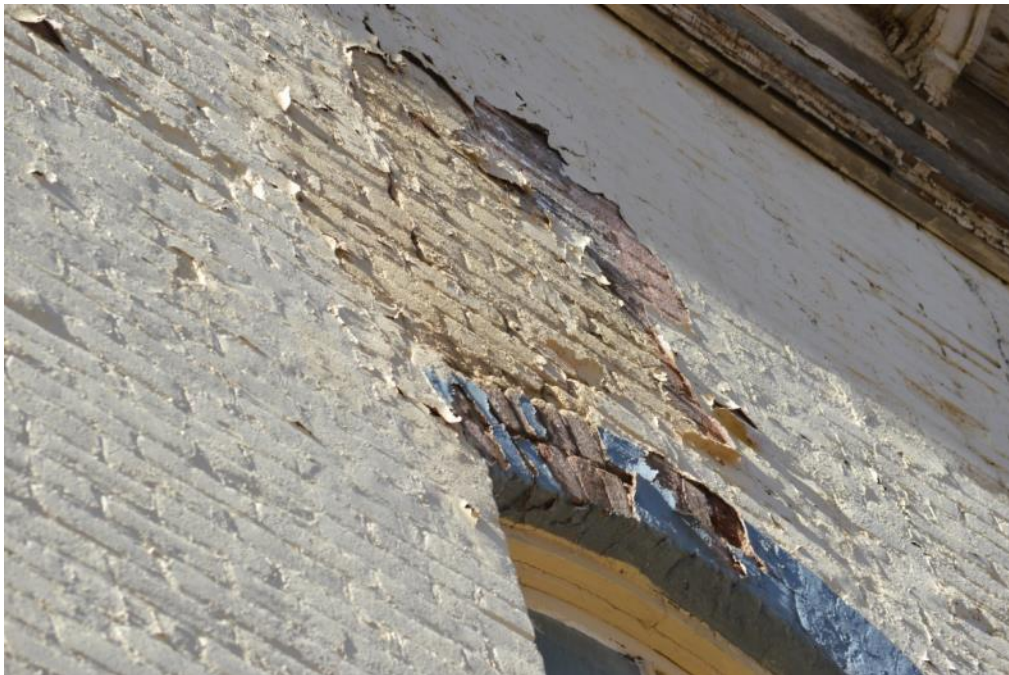
*Figure 81: Detail view of paint deterioration on the east elevation of the theatre section of the building.*

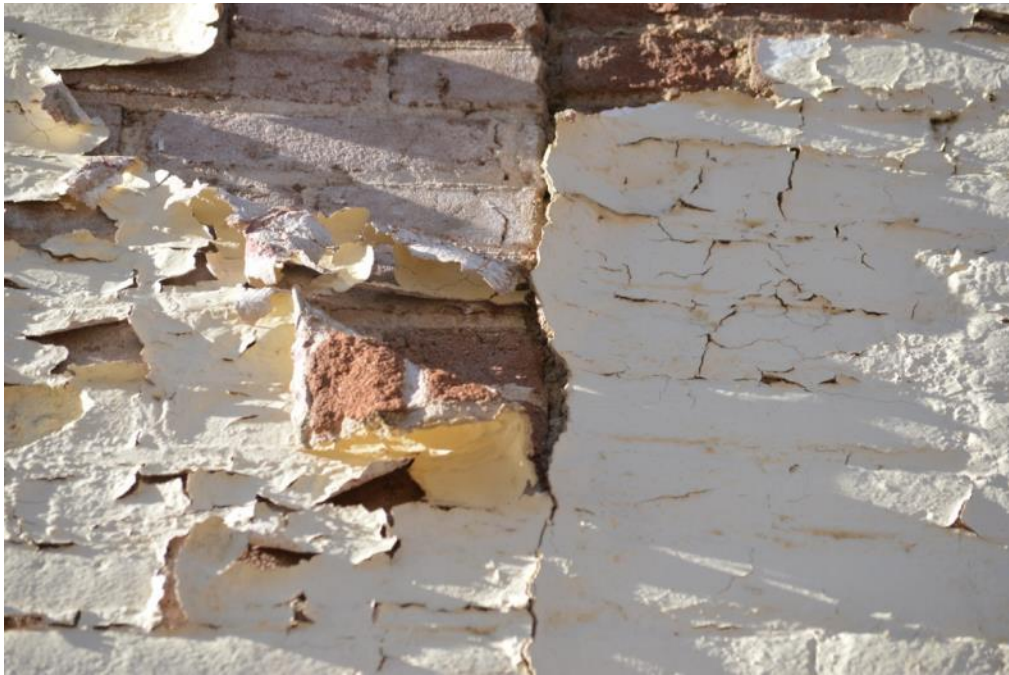
*Figure 82: Detail view of paint failure and masonry deterioration on the east wall of the theatre section of the building. Note peeling paint is taking the faces of the brick off.*

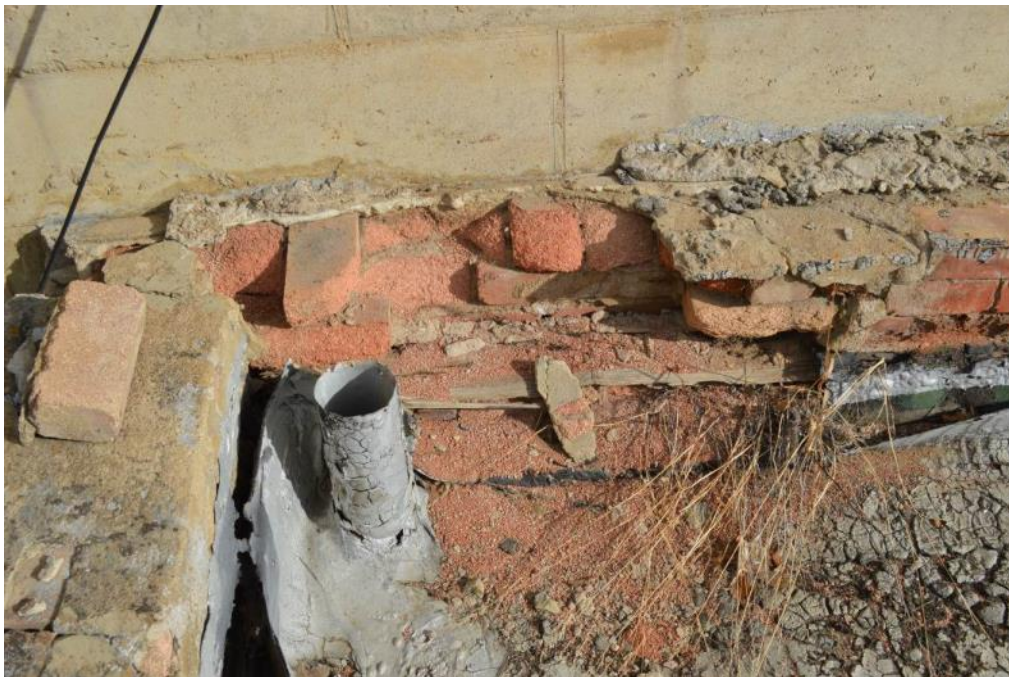
*Figure 83: Parapet deterioration at lower roof to the south of the fly space.*

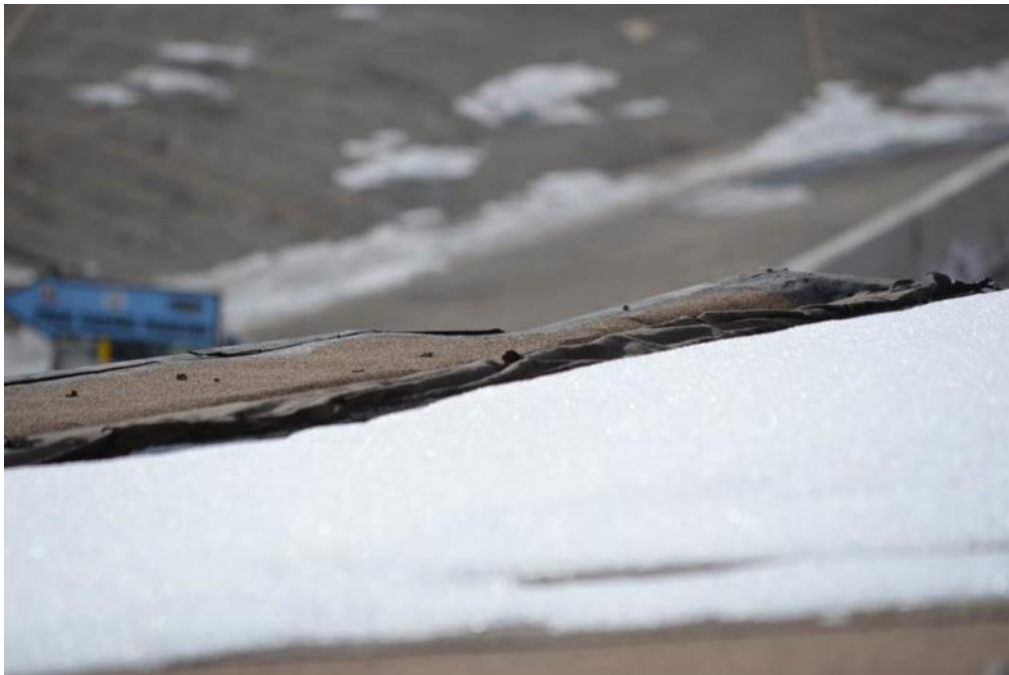
*Figure 104: Detail view of deteriorating roofing material along the east edge of the theatre roof.*

- Replace roof at the east section of the theatre with appropriate roofing material such as corrugated metal panels or asphalt roll roofing. If a flat roof is re-established to match the historic appearance of the building, flat roofing material such as EPDM may be used in this area. (Critical)
- Replace roof on the Shoo Fly section of the building. A membrane material such as EPDM would be an appropriate replacement material for this section of the building. (Critical)
- Replace lower flat roof located to the south of the fly space (identified as the 'cooler' on the lower level floor plan). A membrane roofing material such as EPDM would be an appropriate replacement material for this section of the building. (Critical)
- Replace roof on the fly space. A membrane material such as EPDM would be an appropriate replacement material for this section of the building. (Serious)

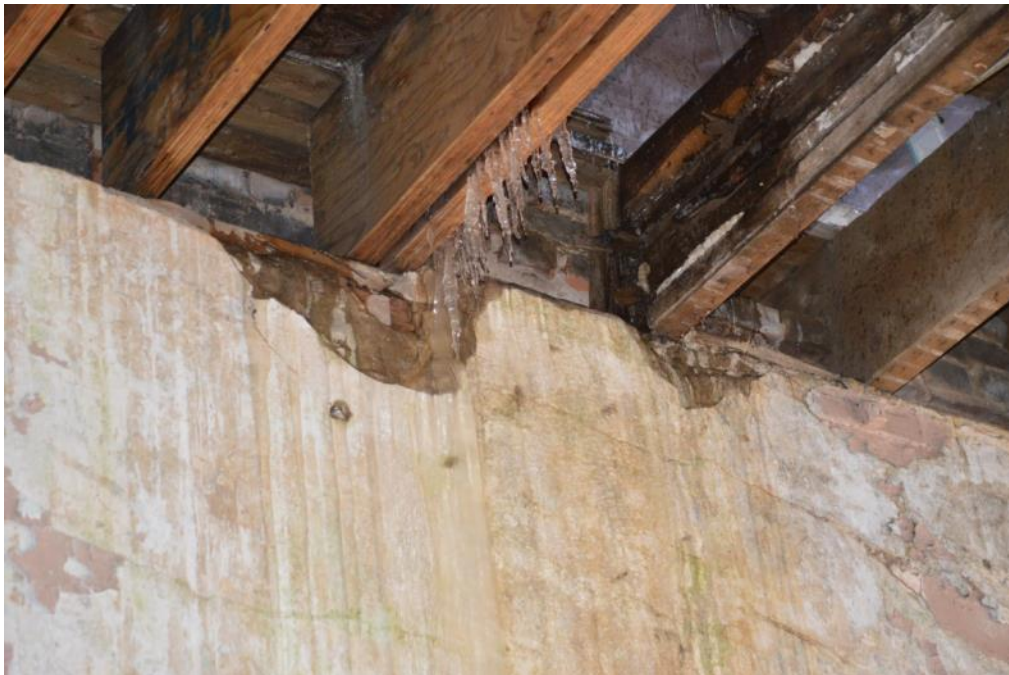
*Figure 106: Water infiltration and ice formation in the lower level of the Shoo Fly section of the building due to the poor condition of the roof.*

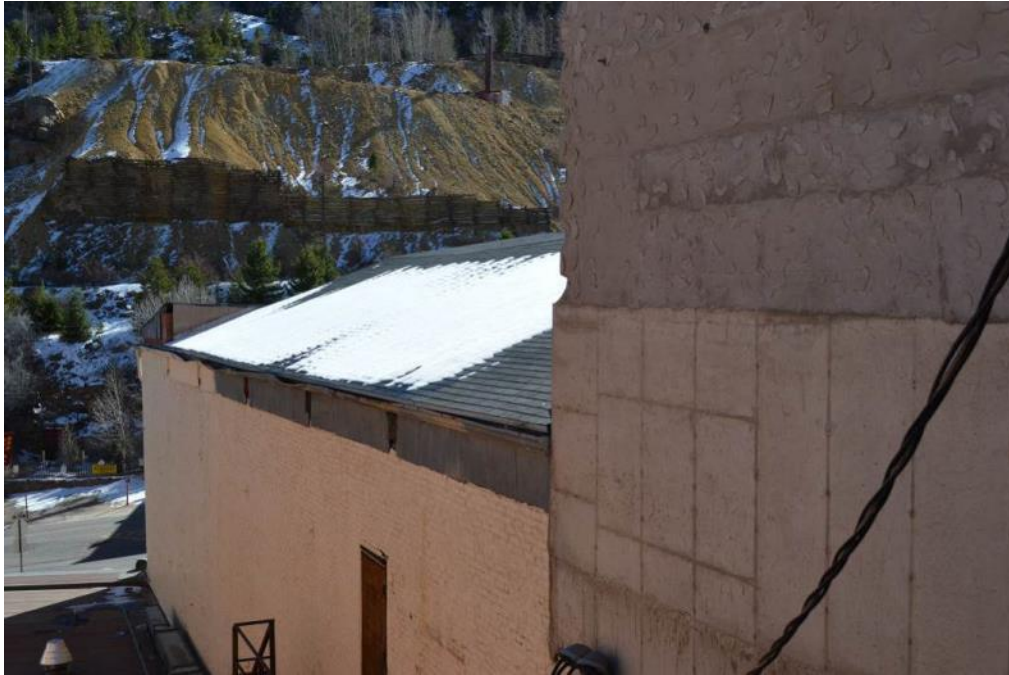
*Figure 109: Gutter along the north elevation of the theatre. Note sections of the gutter are deformed and the finish is wearing off.*

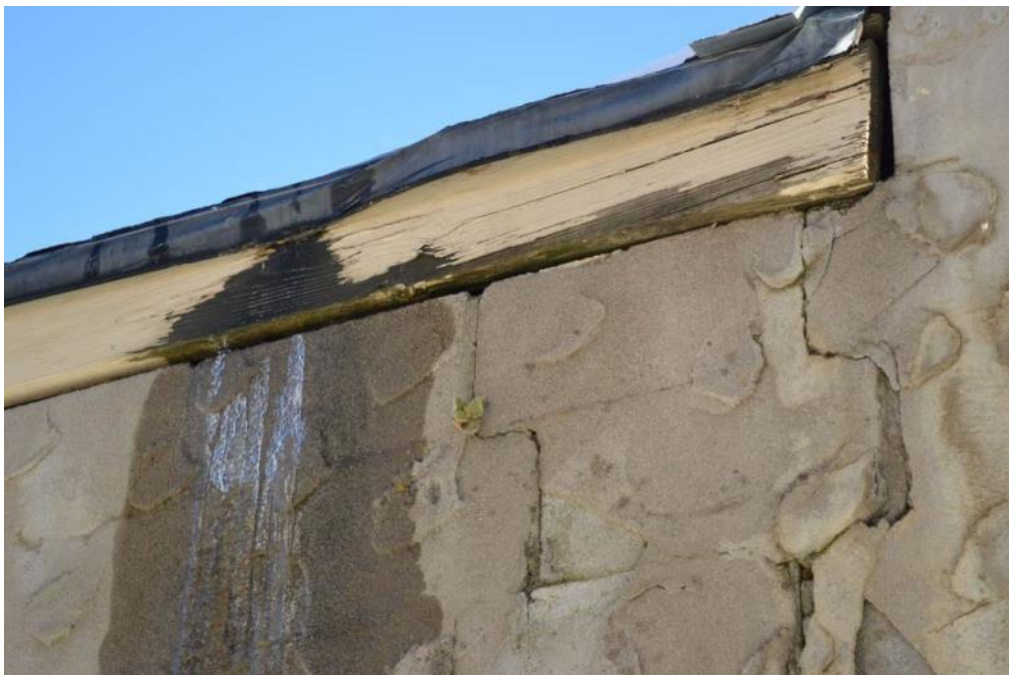
*Figure 112: Fascia deterioration and ice on the face of the west elevation of the fly space due to a lack of roof drainage system on this section of the building.*

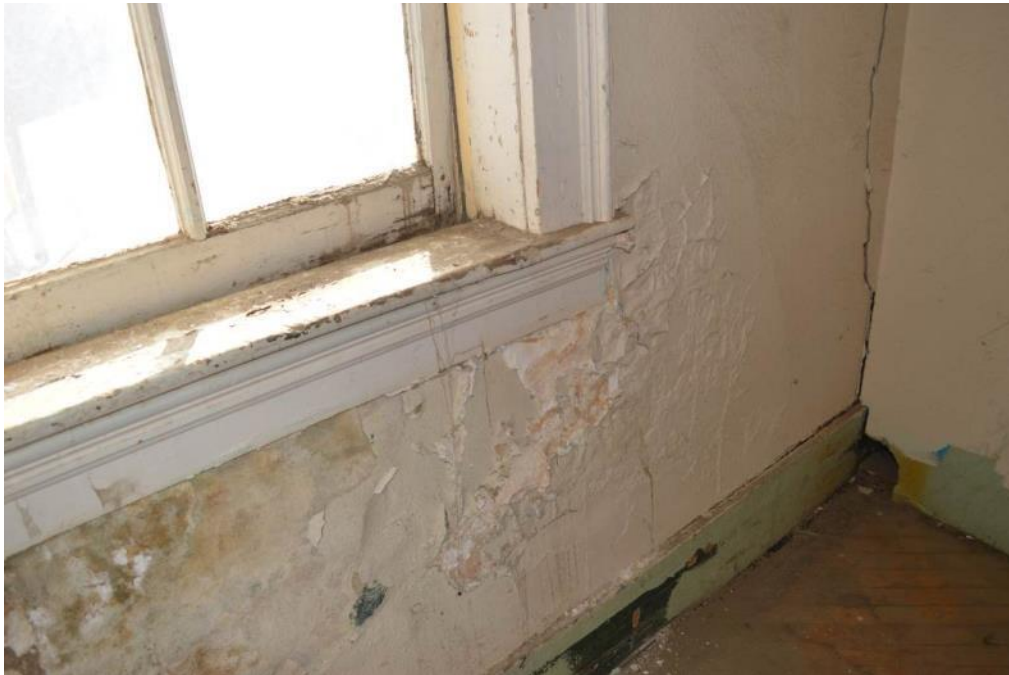
*Figure 156: Overall view of east wall in the women's restroom. Note water damaged plaster below the window. Also note crack in the corner of the room.*

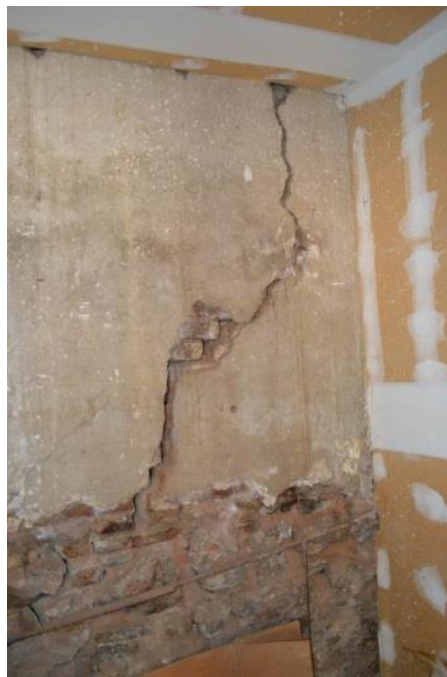
*Figure 157: Large crack in the storage room to the south of the women's room.*

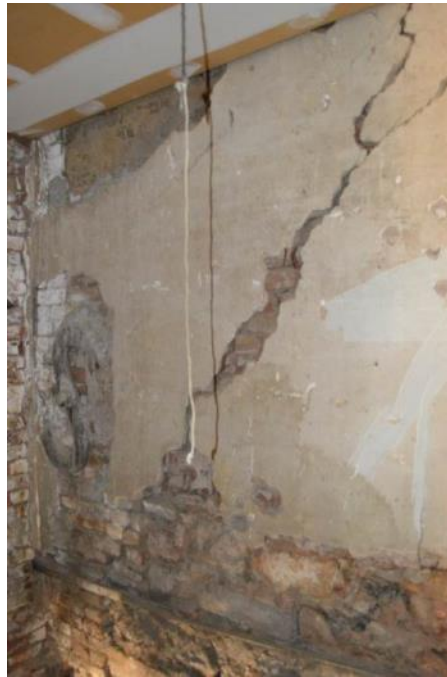
*Figure 158: Large crack in the south wall of the storage room to the south of the women's restroom.*

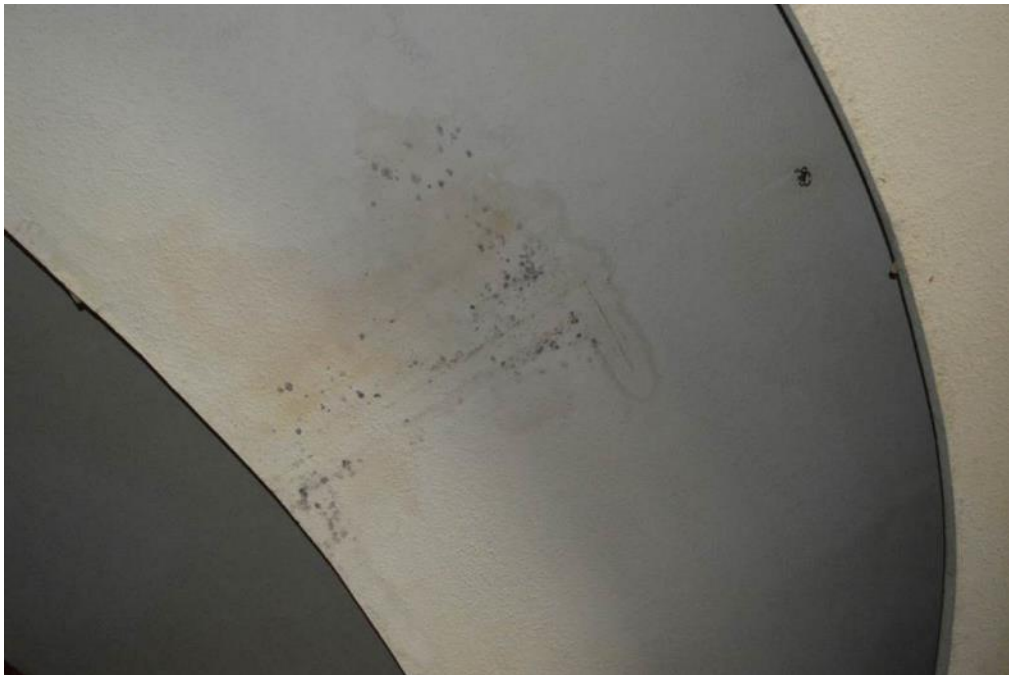
*Figure 163: Detail view of water damage and mold at theatre ceiling.*

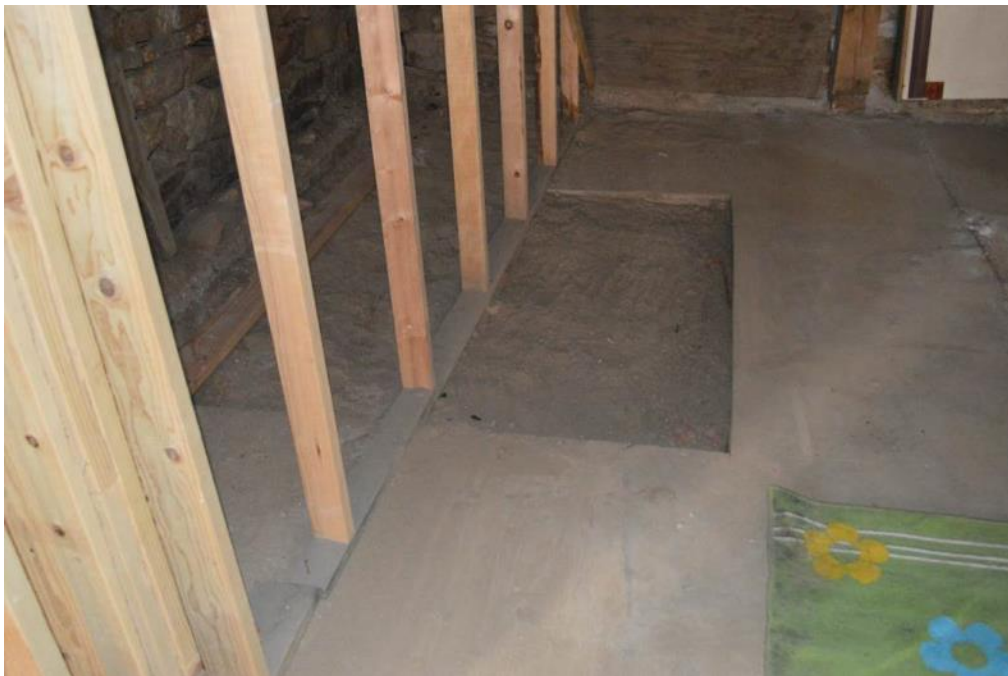
*Figure 164: Concrete floor in the lower level of the building. Note section of concrete has been removed, presumably in preparation for construction activities.*

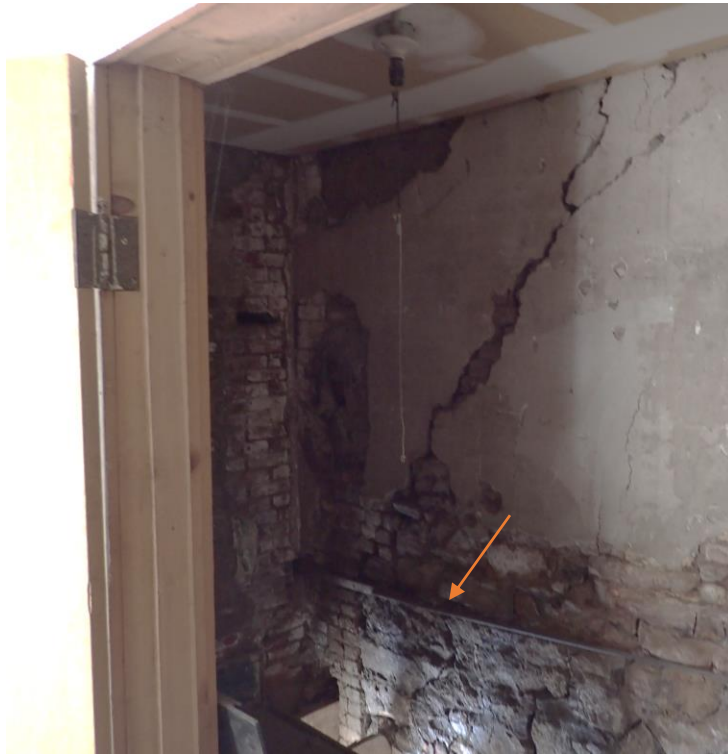
Figure 3: Internal Tie rod at S-anchor plate location. Note large diagonal crack in wall.

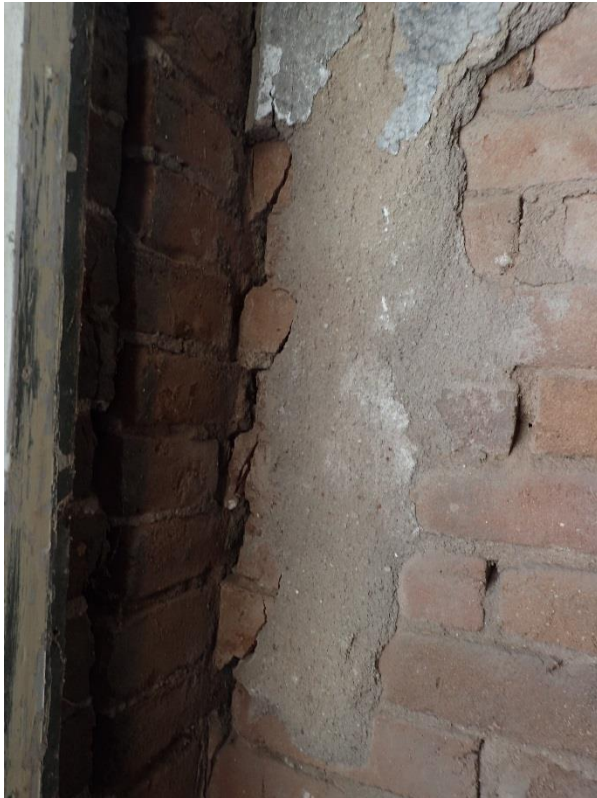
Figure 5: Cracking between façade and perpendicular wall (sheared header bricks at corner)

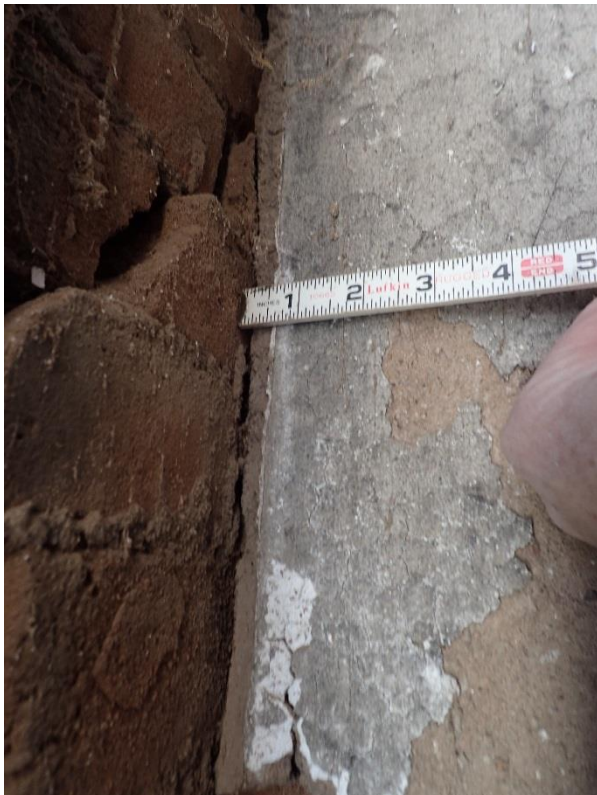
Figure 6: Displacement between façade and perpendicular wall

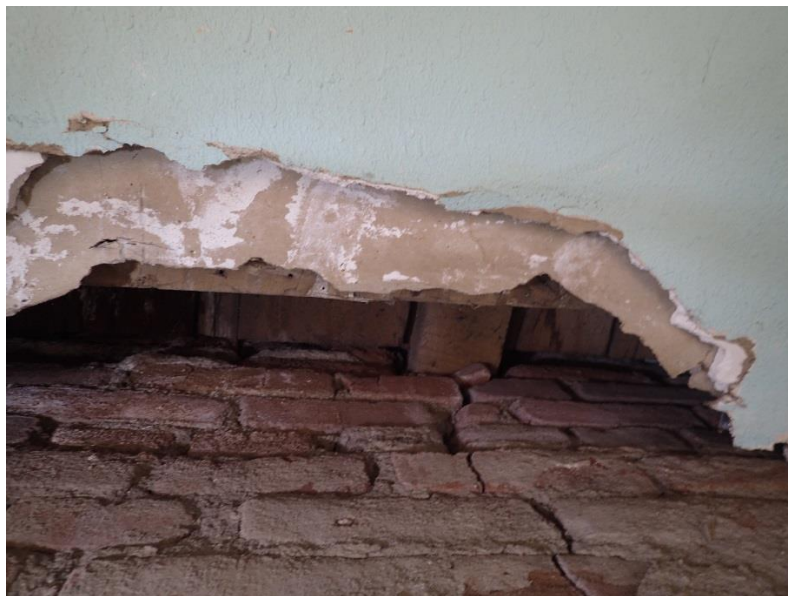
Figure 8: Board pocketed into exterior façade. Note vertical cracking in wall below board.

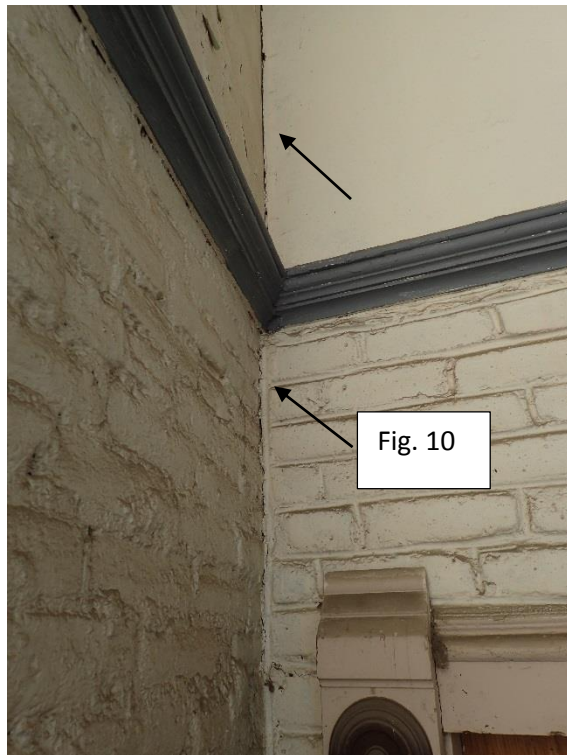
Figure 9: Vertical cracking between façade and perpendicular wall

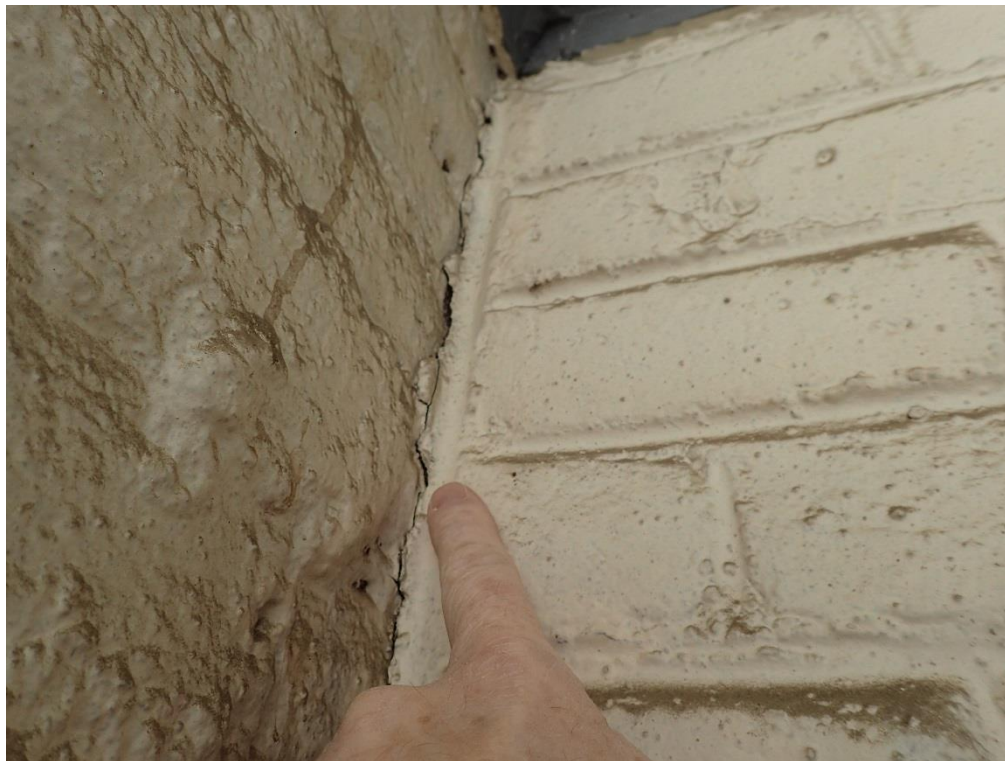
Figure 10: Vertical cracking between façade and perpendicular wall
